Examination report on SAPI – low pressure – cleaning of natural stones
by means of vortex stream technique.

Obligee SAPI GmbH

Date: 07.04.2004

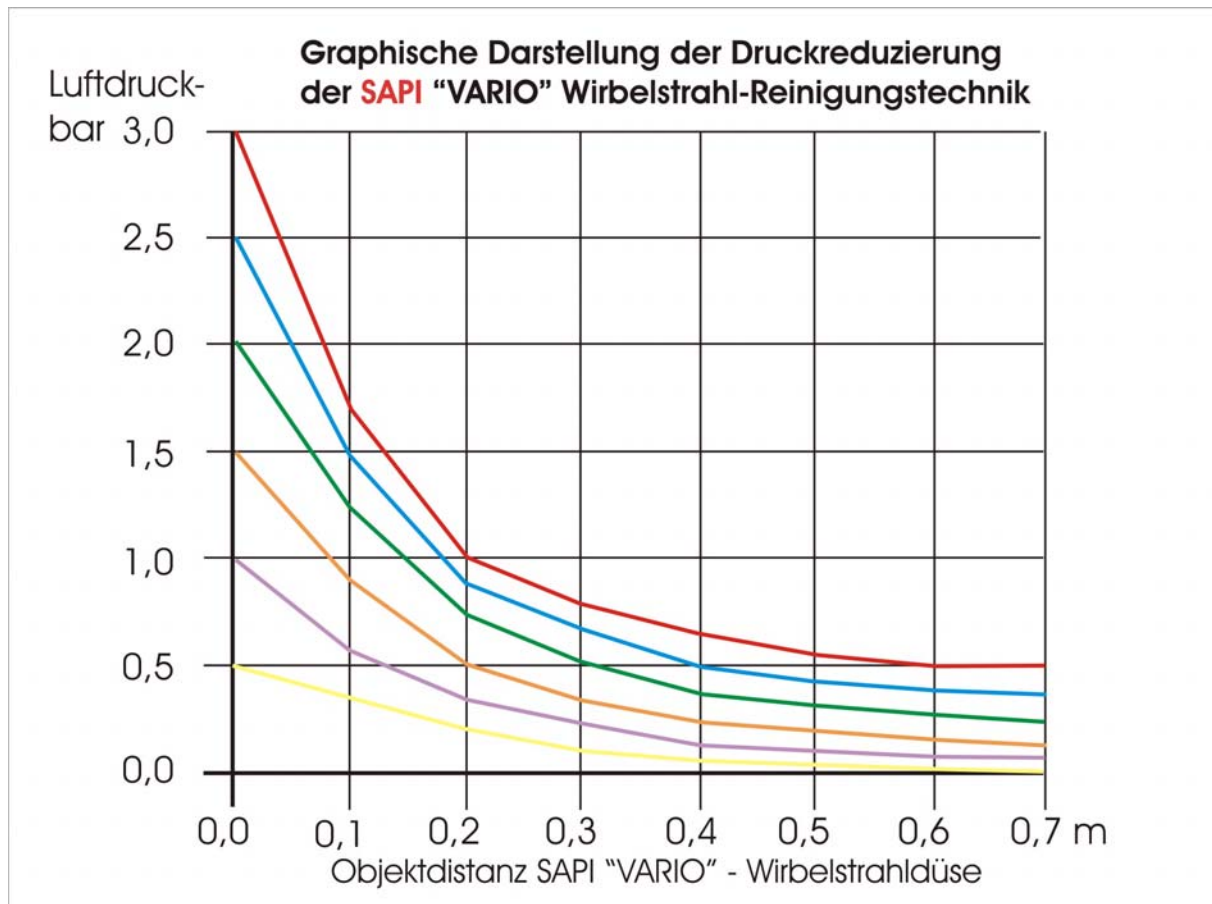
Graphical demonstration of the pressure reduction
of the SAPI "Vario" vortex stream cleaning technique

Object distance SAPI "Vario" vortex stream nozzle

By means of the transmission of the kinetic energy in the inside of the "Vario" vortex stream nozzle from linear into rotating pressure air flow, the air pressure is reduced almost proportionally to the square. This means that a pressure air stream of 3 bar is reduced when leaving the vortex nozzle at a distance of approx. 50 cm to 0,5 bar. The fine cleaning particles are lead in a very flat angle tangentially over the surface to be cleaned and thus provoke a very fine abrasive cleaning effect whereby the textures of the stone surfaces are not being damaged.

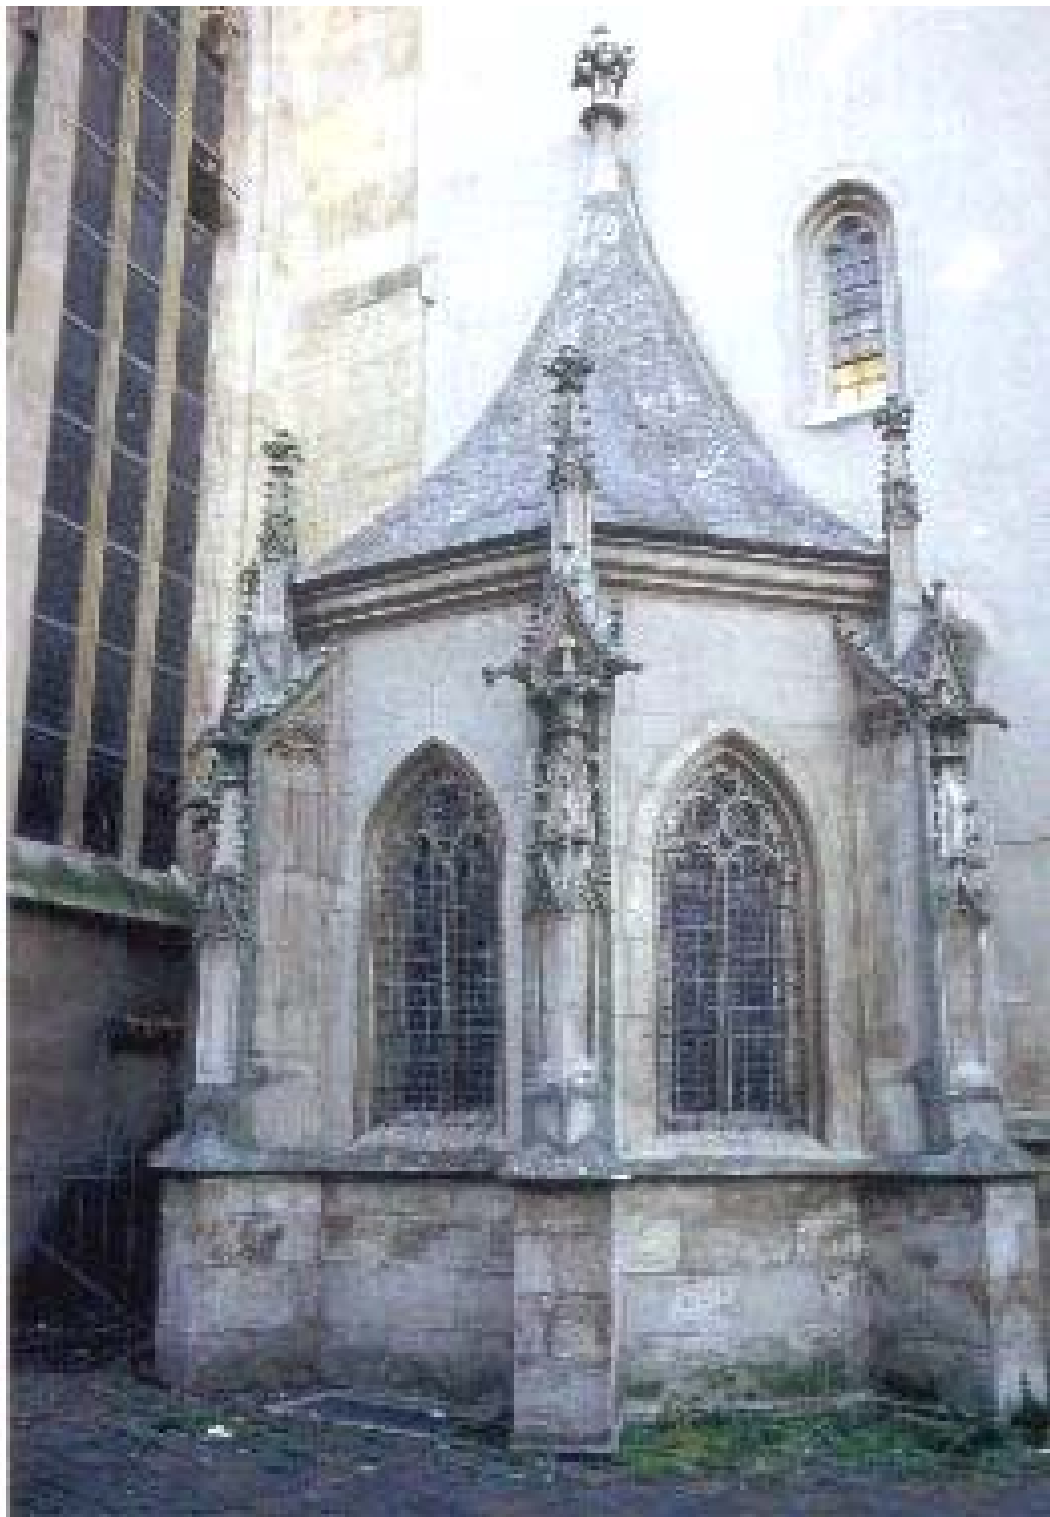
F 1 Cathedral Eichstätt / choir of the capital sacristy
Stone surfaces intensely polluted and encrusted
Upper areas, especially roofage is overgrown with green algae and moss.
Condition before the cleaning

At the moment of the expertise, the surfaces of this object were generally very intensely contaminated, that is to say, the pale limestone was "black" (!) and partially covered with a thin sinter crust (see photo documentation in the attachment)

Partially, the surfaces, especially in the upper areas and the roofage, were overgrown extensively with lichen and moss.

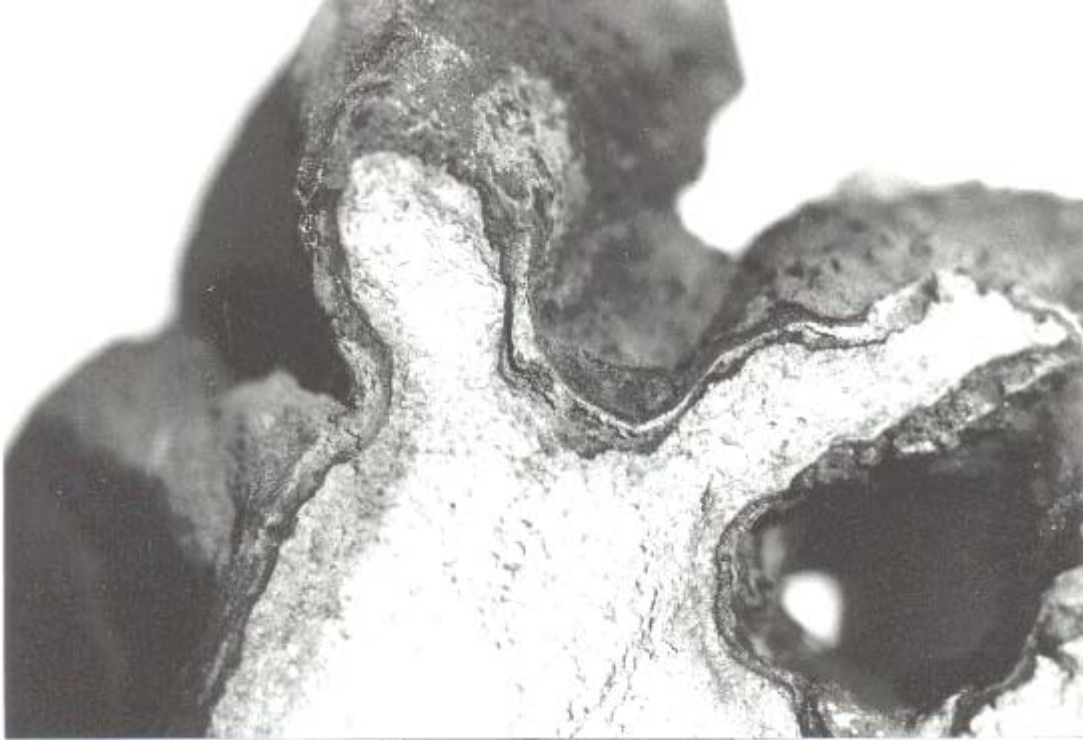
F 3 This fractured surface demonstrates clearly a 1 mm thick pollution / gypsum crust on the limestone surface

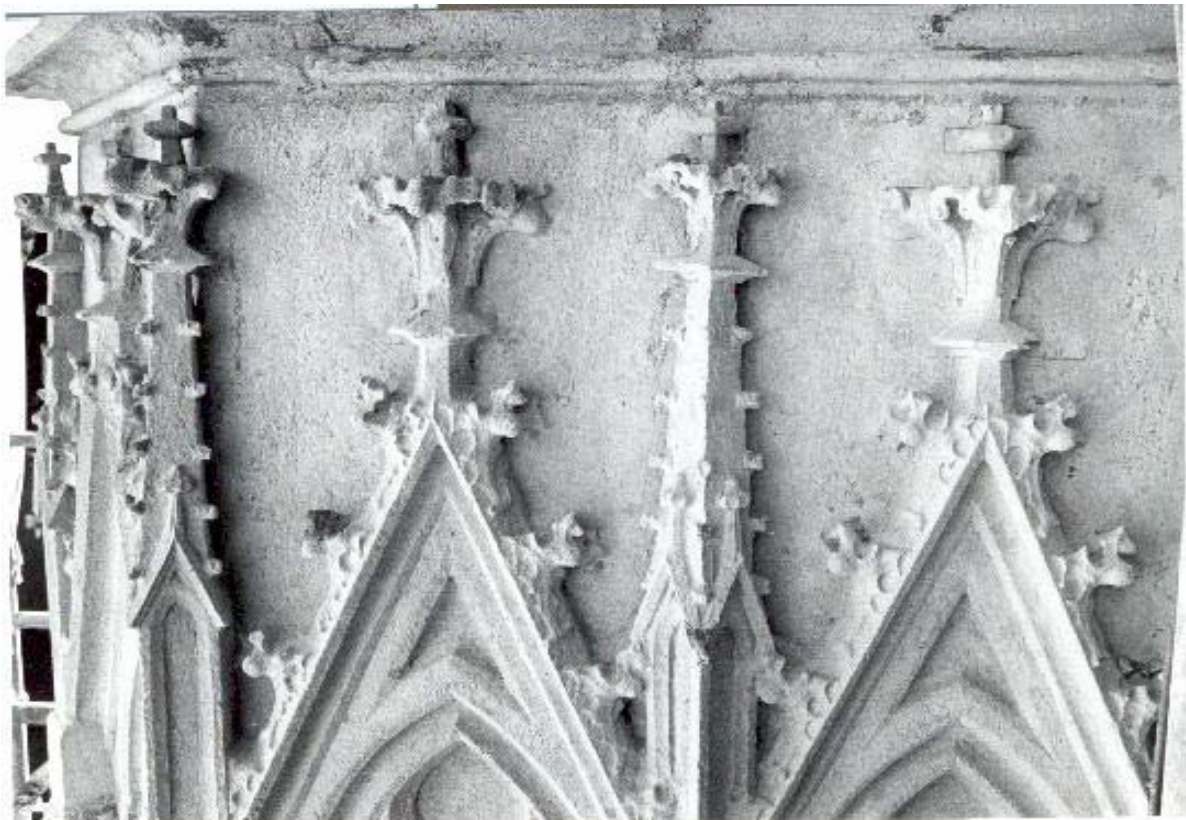
- F 7 Wall after the cleaning
The cleaning with the "Vario" vortex stream technique was carried out as careful and

As gentle so that no damages occurred to the delicate adorning elements and partially even rests of a "patina" were conserved.
